Sanapiro Monument Renovation Work Site Report 13/06/2024

***Description of Work :** Renovation of Sanapiro Monument Area.

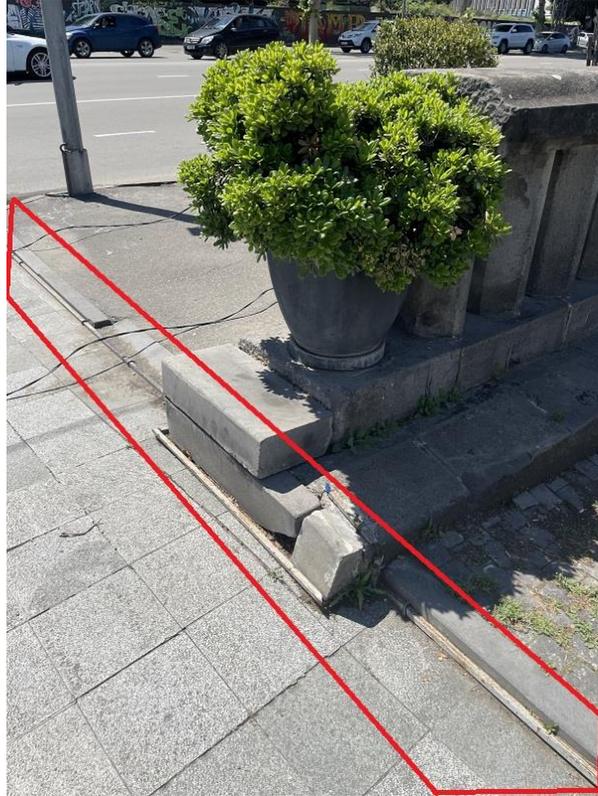
1-Electrical cable on the floor is not protected properly. 25 meter length. If curbs are under control of ours, needs repair.

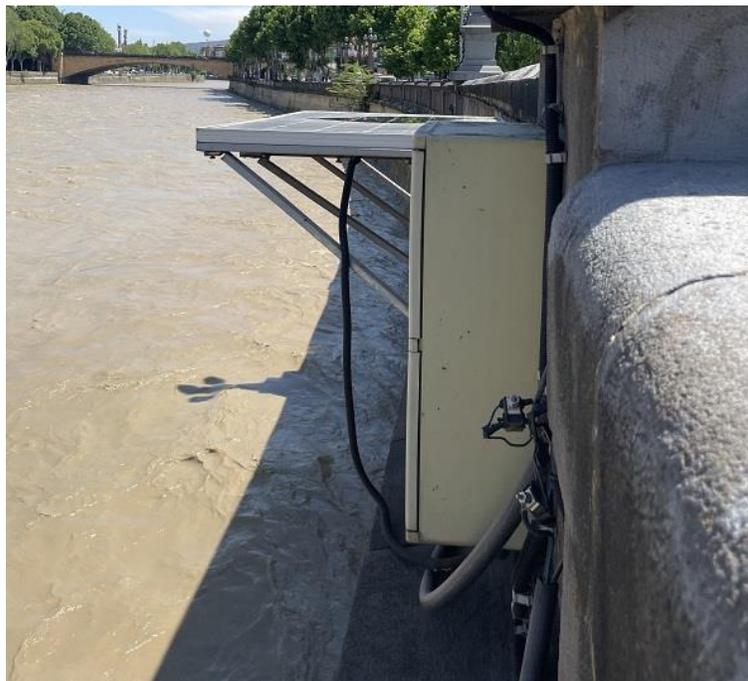
2-Solar panel system is not working at all. An electrician should check it and find out the problem.

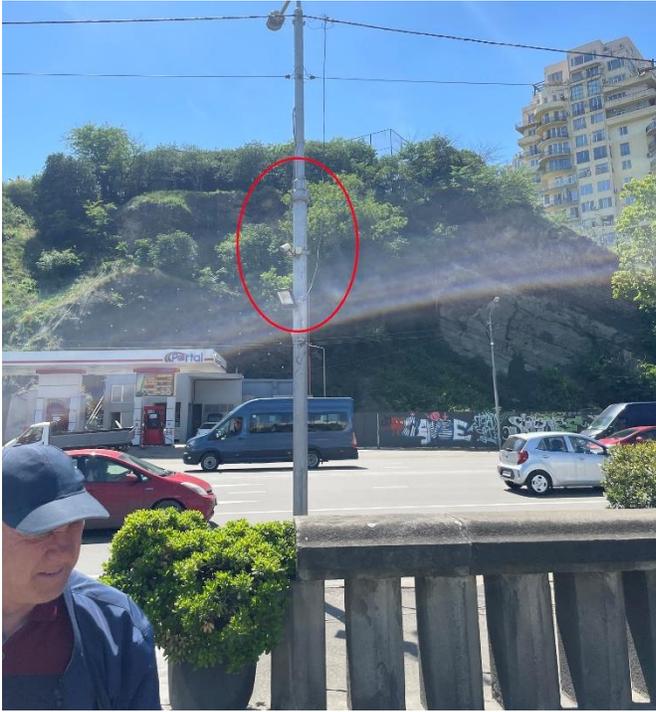
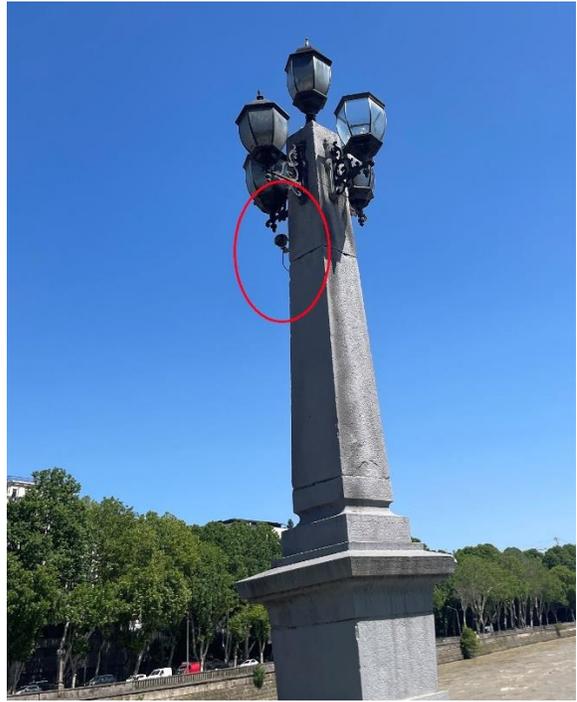
3-Cameras are not working (4 cameras). An electrician should check.

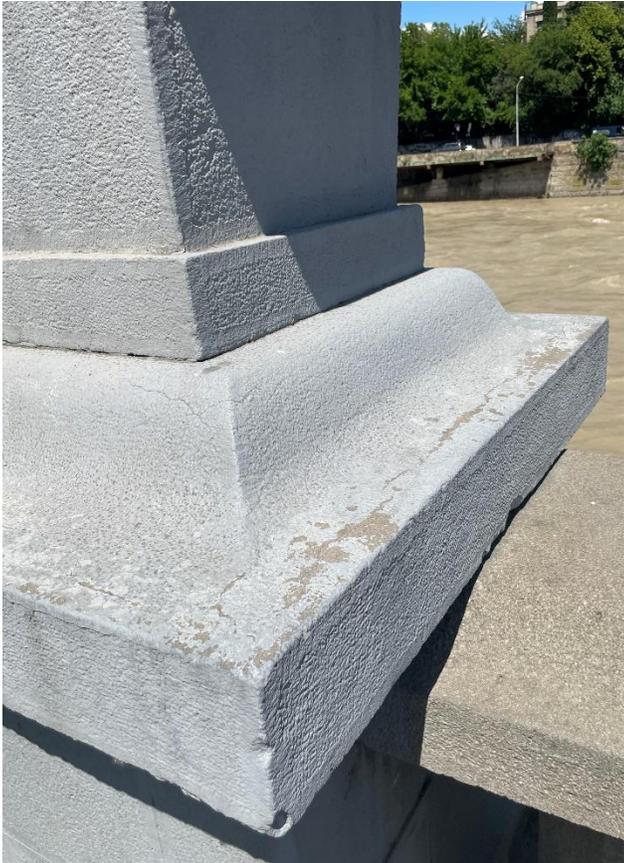
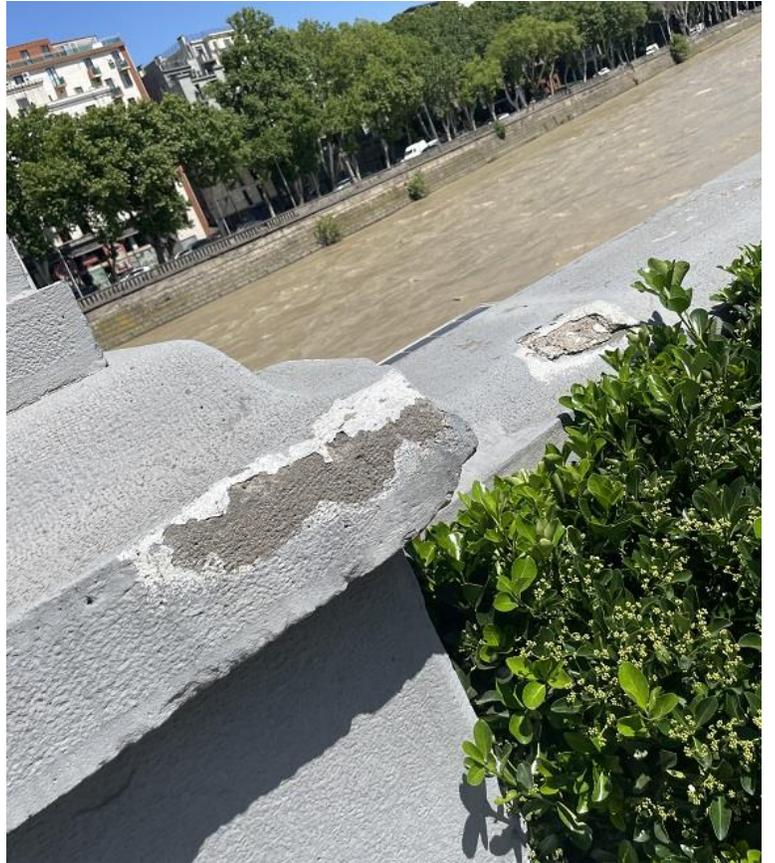
4-If this wall is under control ours, needs repair. Plastering + painting.

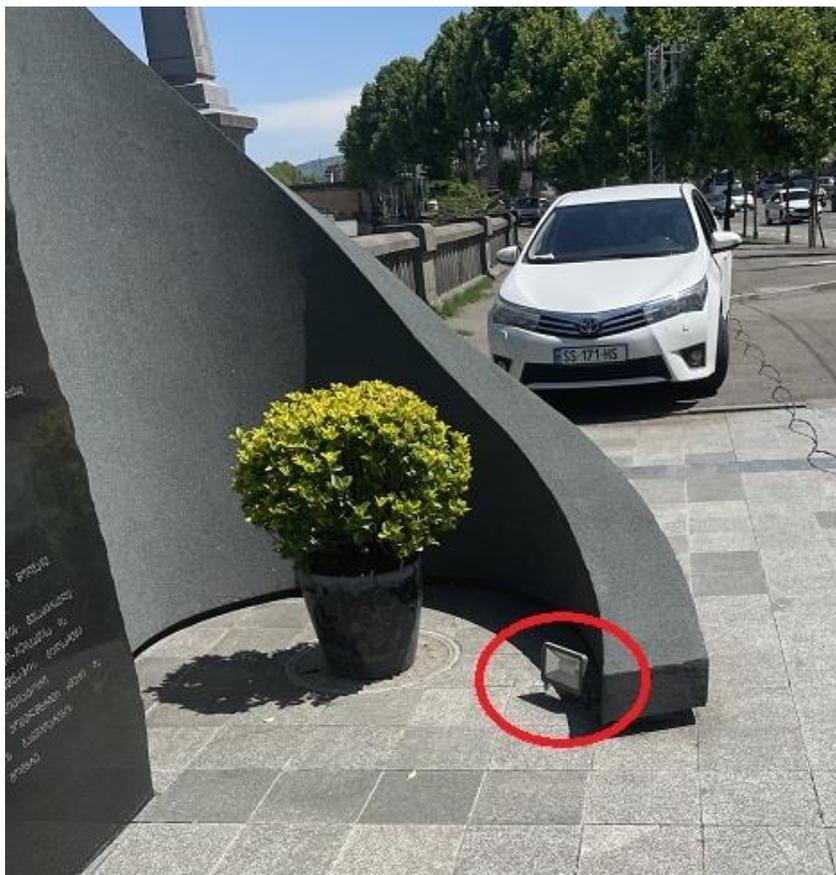
5- Spot light should be checked whether working or not.
