## Tbilisi Mall

### Stage 1, Inspection Report

**Project No.: M8722**

**Document No.: M8722 – RPT 001**

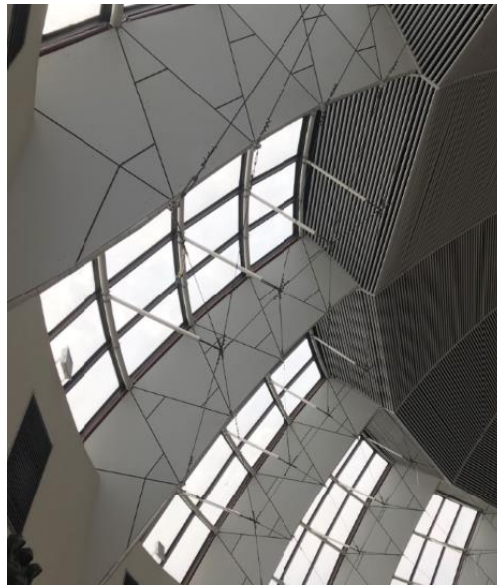
*Figure 1 - The Cladded Space Trusses and Lower Part of the CHS Cladding Grillage.*

A network of steel bracing cables is providing for additional lateral support to the structure of the dome above the central atrium of the mall. See Figure 1 above.

RUD raised the concern that the steel bracing cables may be loose and locally corroded. The tightness of these cables was not able to be observed or measured during the inspection due to insufficient access, however RBG assesses that RUD's evaluation appears reasonable. It is however currently unknown whether the tension system is required from a strength perspective. Refer Figure 1.

A structural model of the main structural elements of the Central Atrium Dome is proposed to be created to properly understand the design requirements of the steel cables within the Dome. Once this is understood, the built structure can be evaluated, and any concerns and/ or recommendations can be communicated along with any recommended tests on the materials.

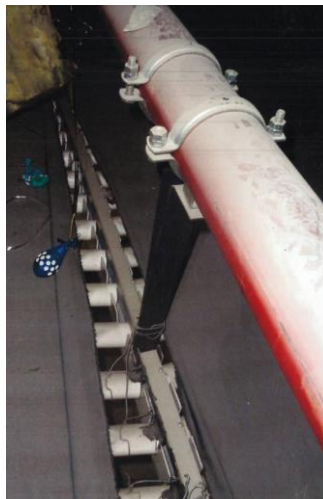
*Figure 2 - Hung Facade; The red member is the main structural steel truss.*

Currently the individual pipes can potentially move and become dislodged from their supports during any lateral action and could present a serious falling hazard. The witnessed support of the secondary CHS Cladding Grillage does not appear sufficient. Refer Figure 2 and Figure 3.

It is also recommended to evaluate whether the wires supporting the central section of the Dome internal façade are to be replaced with equivalent brackets as used in other areas of the Dome (refer Figure 2) and whether an additional bracing system is to be provided for the design to comply with governing standards.

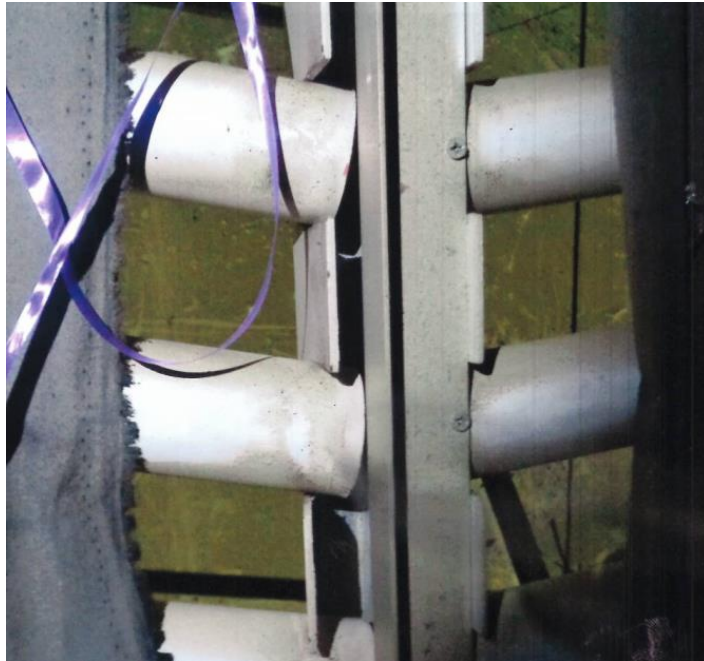
The pipes are supported at each end by steel or aluminum channels. There are numerous instances where the pipes are not connected to the rafters at these support locations and are free to be lifted out of place. Likewise, in many instances, very little bearing is observed.

*Figure 3 - CHS with limited support.*

A risk assessment and solution optioneering are to be done for the pipes that are not securely fixed in place. Following this optioneering phase the most viable option shall be developed and detailed for implementation, if the currently installed cladding solution is found to be inadequate, the most viable option can be implemented.

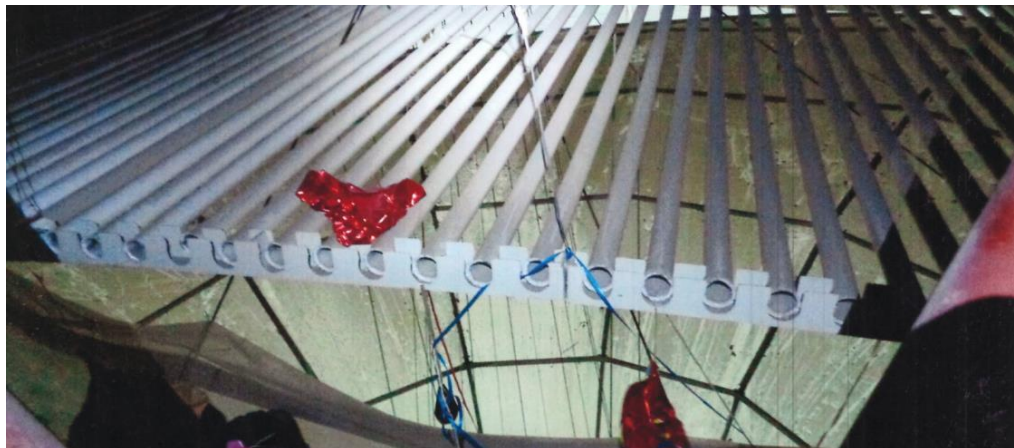
The rafters that are supporting the pipes in the uppermost area (the central part of the Dome) are connected to the steel truss work of the dome via steel tie wires. These tie wires appear inadequate to provide any lateral stability because they are not braced, in the central dome area.

*Figure 4 - Centrally Elevated Unbraced Grillage*

The combined group of pipes in the uppermost section are not braced and is therefore free to sway. This action could impart forces into the tie wire connections whose capacities are unknown. Refer Figure 4.

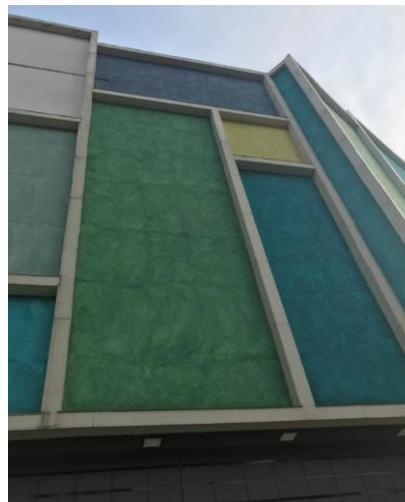
- A secondary steel framing is supporting the cladding panels (stucco board; a light foam-like boards with a harder outer surface). These appear to have been glued onto the secondary steel framing with a silicone-like product. Not other connection was identified.
- Larger painted panels, which appears to be laterally supported by the block wall behind. The connection between these two is unclear.

*Figure 5 - Typical Area of the West Facade*

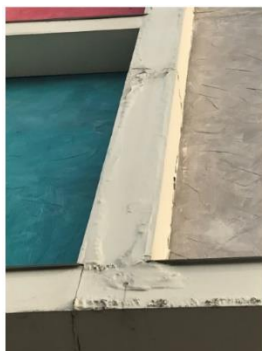
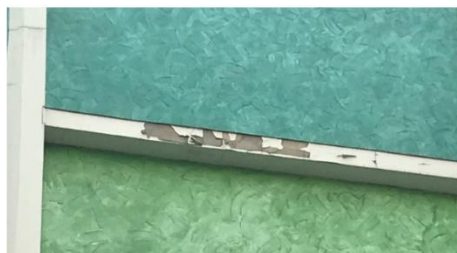
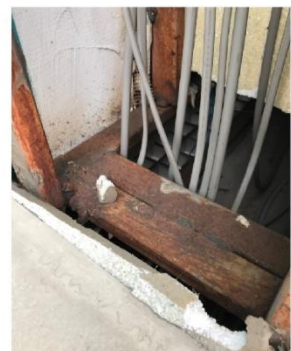
- Corrosion of secondary steel framing members.
- Cracks appearing through the paint/ stucco finish of the cladding.
- Peeling/ bubbling/ delamination of paint.

*Figure 6 - Identified Deterioration*

1. The steel framing does not appear to have been sufficiently corrosion protected. Typically, aluminium framing is used for this kind of secondary façade-supporting structure, however if steel is selected the protective treatment needs to be selected carefully to ensure adequate durability resistance in both the framing and all connections.
2. The panels do not appear to have been fastened with any physical connection aside from the mastic/ silicone material.
3. The selection of the stucco boards does not seem durability-wise adequate to sustain a significant duration. This obviously depends on the Clients requirements for maintenance and aesthetics.

More investigation needs to go into identifying the best solution for the cladding. Due to the significant area, potential cost and the impact during the rectification works it is essential to identify the most appropriate solution to the façade rectification.

It is recommended that a consultant will formulate and propose a series of options for RUD to discuss with their contractor of choice and thereafter be implemented.

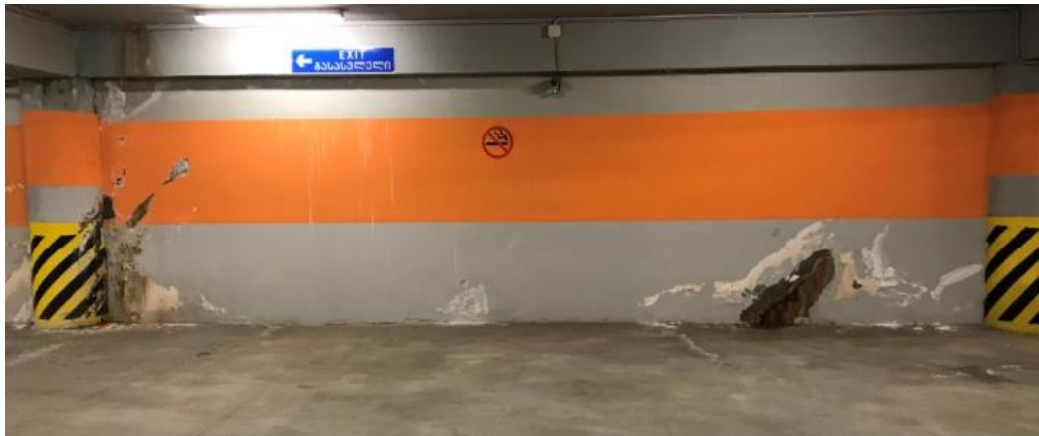
Some of the observed cracks in the retaining wall can be seen in Figure 7 and Figure 8.

*Figure 7 - Cracks in the Retaining Wall*

It is essential to assess whether the cracks in the walls and beams come from differential settlements or from the 3 levels of unbalanced soil pressure, which is imposed by the basement.

Therefore, it is proposed that a structural model is to be created, to assess the existing structural design to establish if acceptable forces and movements are expected. The design review of the wall and beams will thereby identify whether the design is code compliant and reveal any potential inadequacies.

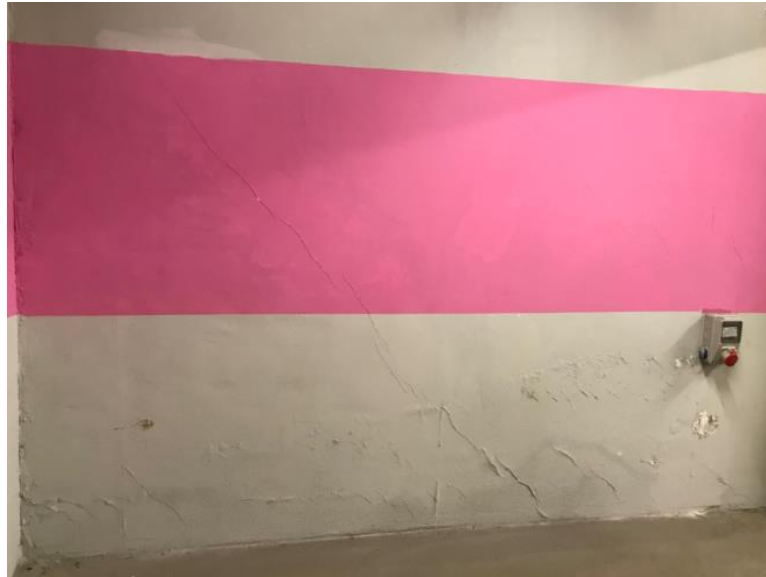
*Figure 8 - Cracks in a Wall Perpendicular to the Retaining Wall*

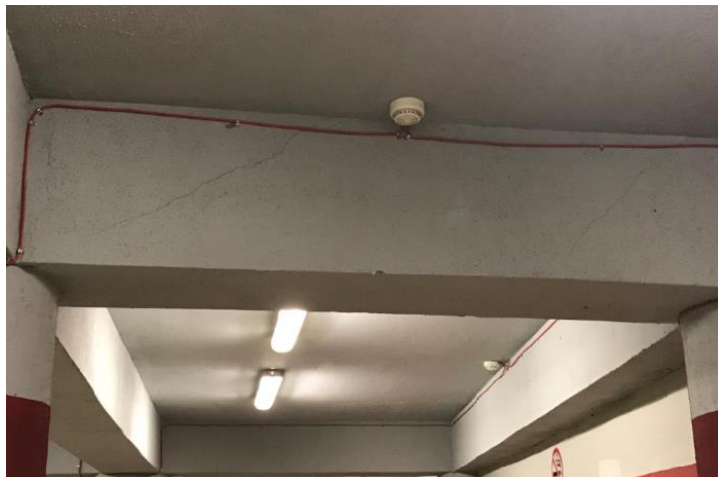
The cracks in the beams follow the same pattern as shown on Figure 9, indicating either an excessive differential settlement or lateral displacement. The foundation system is a raft, except for the towers, which are piled.

*Figure 9 - Cracks in Beams*

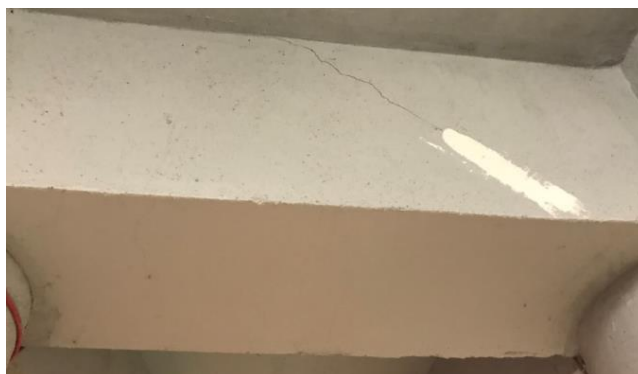
A few of the beams have been locally repaired about 8 months ago, to identify whether the crack was developing. No cracks were opening wider, which appears to indicate that the structure has found an equilibrium.

*Figure 10 - Repaired Area of a Beam*

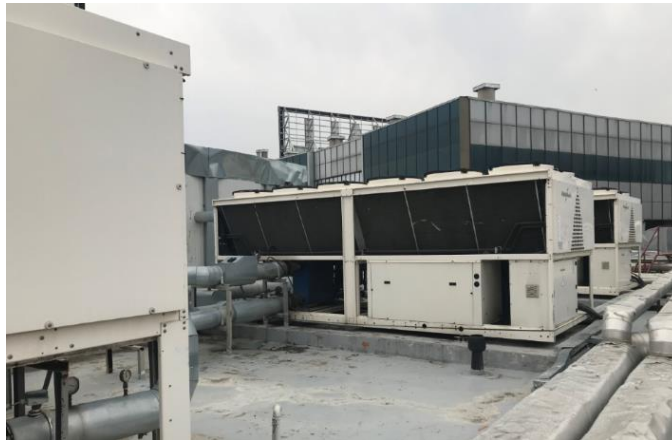
The roof slab directly above this area is highly loaded due to the presence of MEP plant and equipment.

*Figure 14 - MEP Equipment on the Roof*

- The roof span increases from the designed span of 8 m by 8 m to a significantly larger span, approaching 24 to 32 m.
- The roof carries localized heavy-duty MEP equipment which needs to be kept operational during the construction. This poses strict procedures for the construction methodology and erection sequence (CMES).

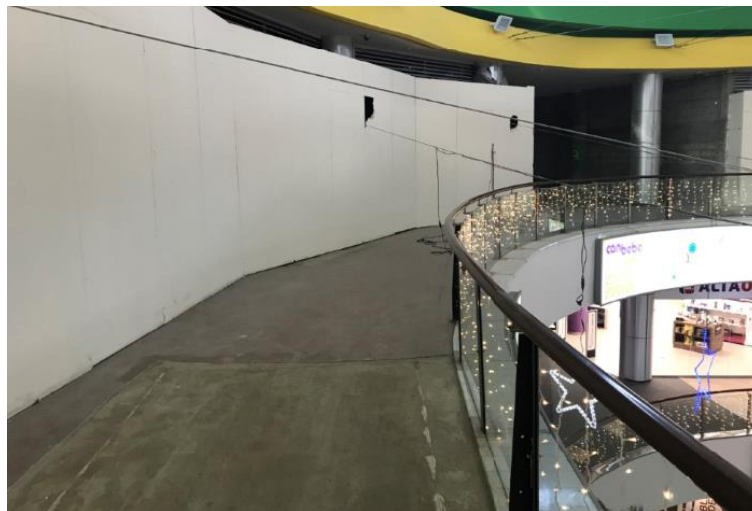
Due to the proposed removal of the slab some areas are very sensitive to the potential loss of stability. Refer e.g. Figure 15, where a 3 m long cantilever will not have its back span. The full structure therefore needs to be evaluated and details to be produced for all relevant areas and all interfaces between the existing and proposed structure.

*Figure 15 - 3 m Long Cantilever which will not have a back span*

- Some areas will lose their natural equilibrium, e.g. as outlined in Figure 15. Appropriate measures are critical both in the construction phase and the permanent works design to ensure that the stability is maintained.

A structural model needs to be created to evaluate the existing structure in order to establish if the structure is acceptable and code compliant. Only once an understanding of the structure has been established can alterations such as removing slabs and columns be considered and assessed along with possible retrofitting solutions.
