Hydropower plant

Document N 001

Rehabilitation of the water supply tunnel

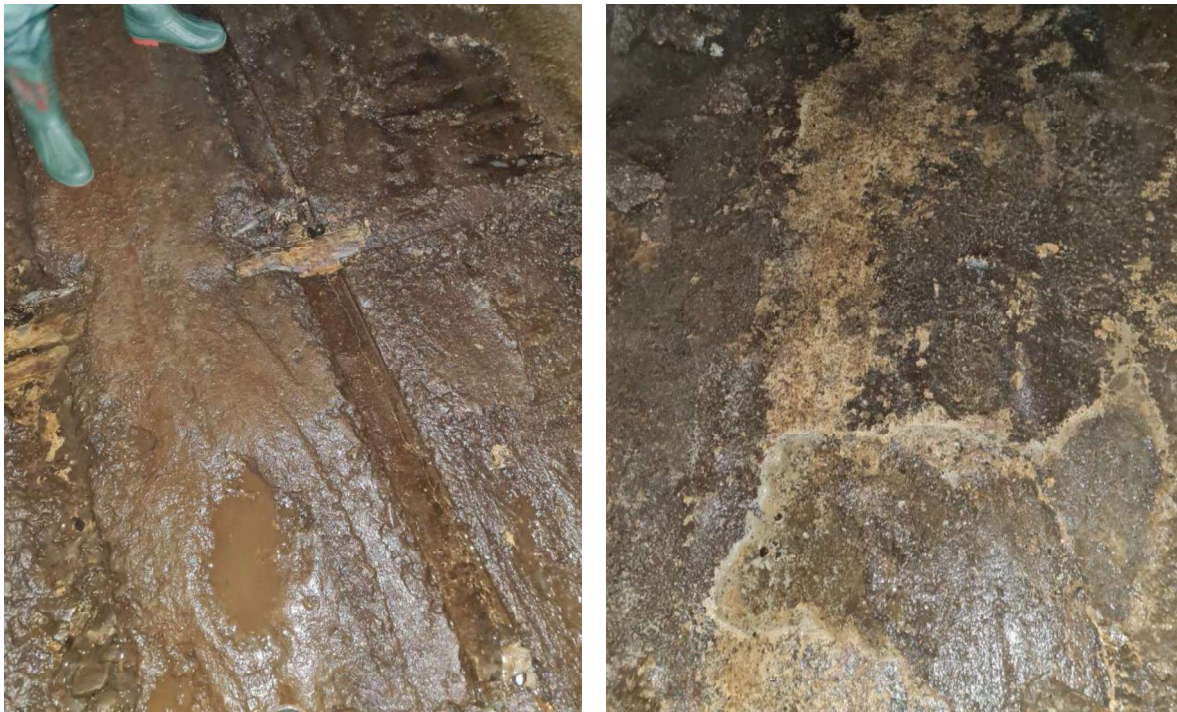
At the bottom of the tunnel there are some irregularities, which seem to be left over from the construction period.

The slope of the base is significantly variable, and in certain sections we have reverse slope, due to which a significant amount of water is trapped in the tunnel.

It should be said that under the conditions of tunnel operation, as the visible water level line on the walls of the tunnel shows, it is quite low and there is no danger of switching to the pressure mode. Therefore, such a defect cannot be considered as a threat to its stability.

Uneven tunnel bottom - pictures N1 and N2

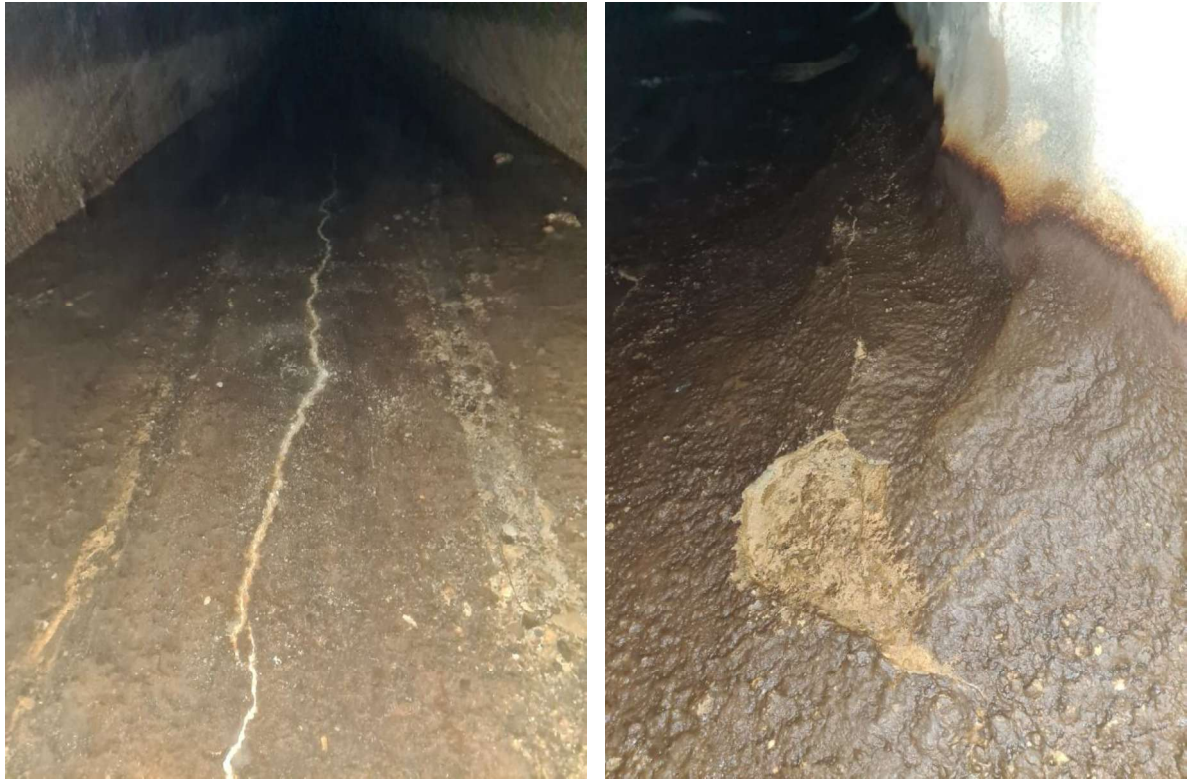
In certain sections, particularly in areas with low water levels or water-free areas, there are visible protruding parts and also cracks on the bottom of the tunnel. It was not possible to accurately measure the damaged parts of the base, due to the high water level in the main sections of the tunnel.

However, in certain sections, significant bulges and cracks are observed, which may be due to high mining pressure or filtration events. The damage mentioned is noteworthy and requires urgent intervention.

In addition, in certain sections of the tunnel, on the bottom along the axis, cracks of different lengths and distribution are visible, which is also noteworthy.

Bulging and damaged bottom of the tunnel - pictures N3 and N4

As mentioned above, in several places, the bottom of the tunnel is quite damaged, and therefore the stability of the entire excavation is also weakened. Therefore, it is necessary to restore similar sections, which should be carried out as follows:

- The damaged concrete lining of the tunnel must be removed mechanically;
- Any foreign bodies such as wooden material should also be removed. Waste, any contamination, etc.

- To achieve a better grip, the screed should be drilled into the old concrete 15 cm drills and install rebar anchors, 30 cm long and 14 mm in diameter. The ends of the anchors should point toward the center of the opening being removed.
- If the concrete base is reinforced (at this stage there is none There is no proof), the new reinforcement mesh should be arranged in accordance with the existing one and connecting the reinforcement rods together.
- Places to be filled with concrete should be cleaned and washed of any foreign matter from body and substance;
- Needed In this case, the existing forms of the tunnel should be arranged according to the parameters;
- Pouring of concrete should be done using vibration.

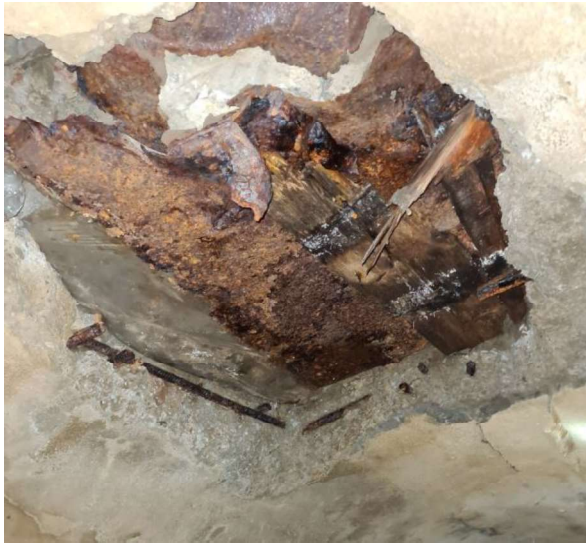
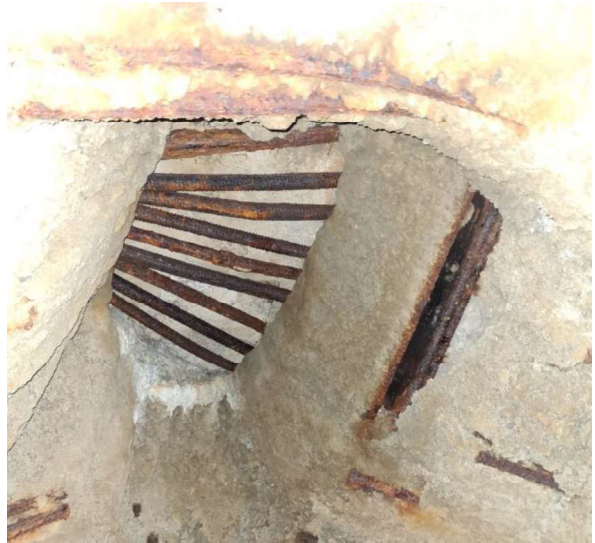
In the bend of the tunnel, there are artificially created holes at certain sections. The mentioned holes may have remained from the period of construction or subsequent rehabilitations, and they were probably used for communication purposes. In particular, to supply construction materials or to introduce electricity supply, water supply or any necessary network into the tunnel. Most of these holes are currently sealed by artisanal methods. However, in order to carry out the planned rehabilitation works, it is recommended to study the places of their emergence to the surface and use them if proper access and safety measures are ensured.

Holes in tunnel bend - pictures N5 and N6

After the work is completed, some of them may be reinforced and left for future use.

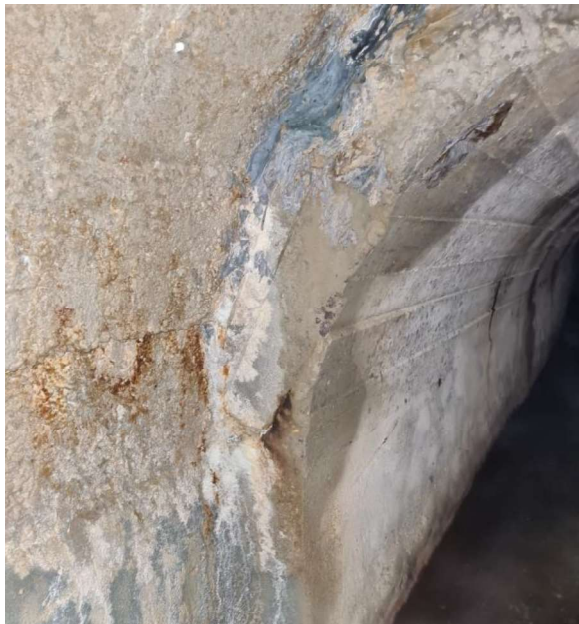
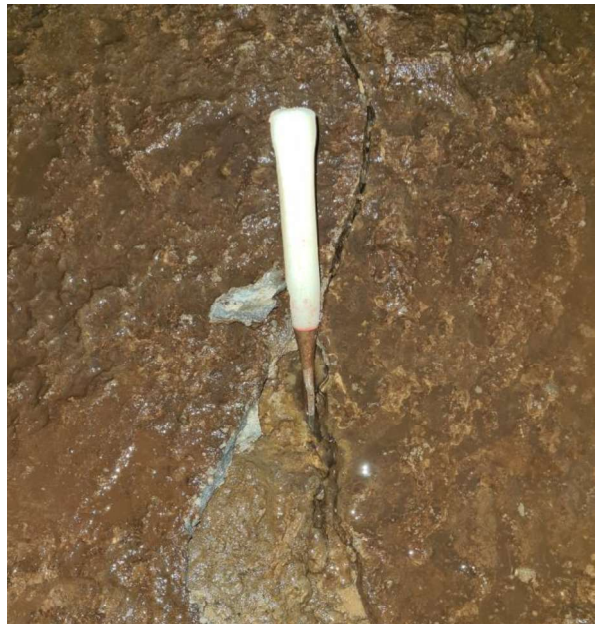
Along the entire length of the tunnel, there are damage and cracks of the construction seams, which may become a source of water leakage from the tunnel and also cause a weakening of the stability and reliability of the tunnel over time, which in turn will lead to a decrease in the safety of the operating conditions.

Damaged construction seams - pictures N7 and N8

Therefore, it is necessary to open and process the mentioned seams using appropriate technologies.

Repair of the construction seams of the tunnel must be done in the same way as the crack treatment sequence. However, the difference is that the construction seam must be cut to a depth of 3-4 cm, and to improve the waterproofing, a suitable amount of waterproofing material such as Sika "Swellstop" or "Swellstop II", or a product with similar properties, released by another manufacturer, must be placed in the cut groove.

After installation of the water barrier, the seam should be treated in the same sequence as the crack treatment.

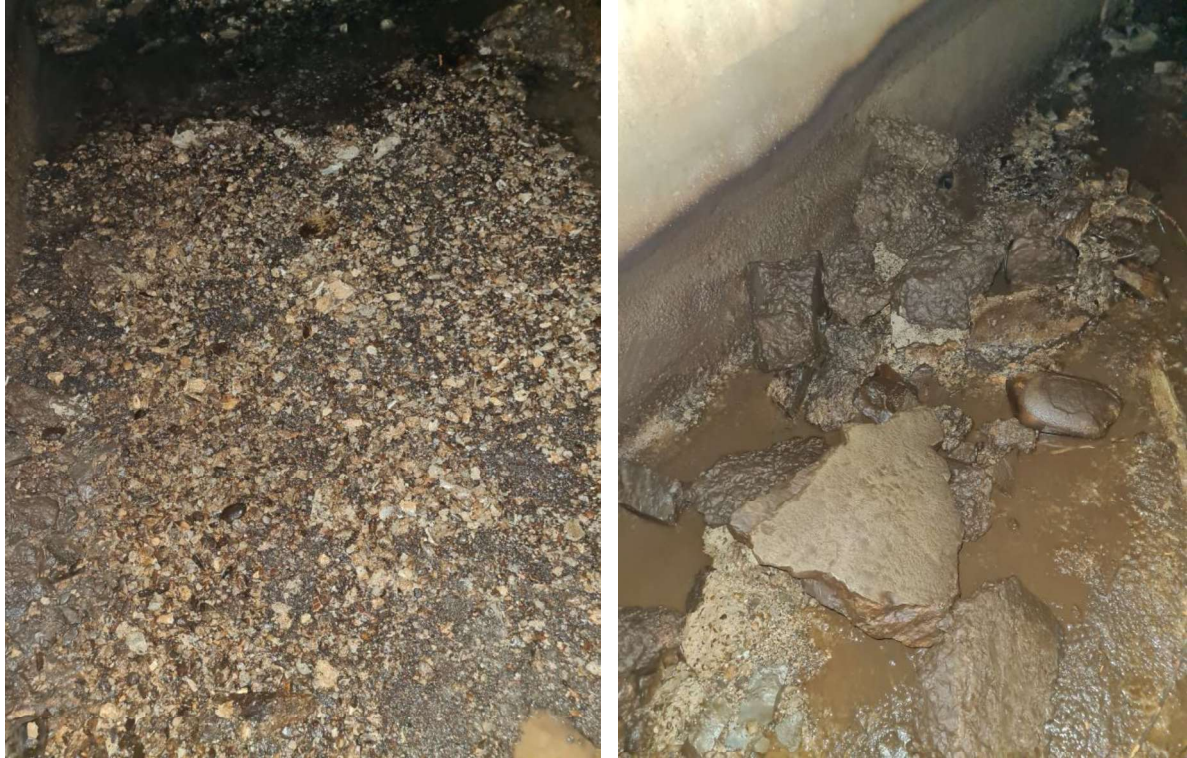
At certain sections of the tunnel, piles of both imported waste and construction material waste can be observed. Although they do not pose a threat to the stability of the tunnel, their removal is necessary, even during the planned rehabilitation period, to ensure smooth movement inside the tunnel.

Debris deposited inside the tunnel - pictures N9 and N10

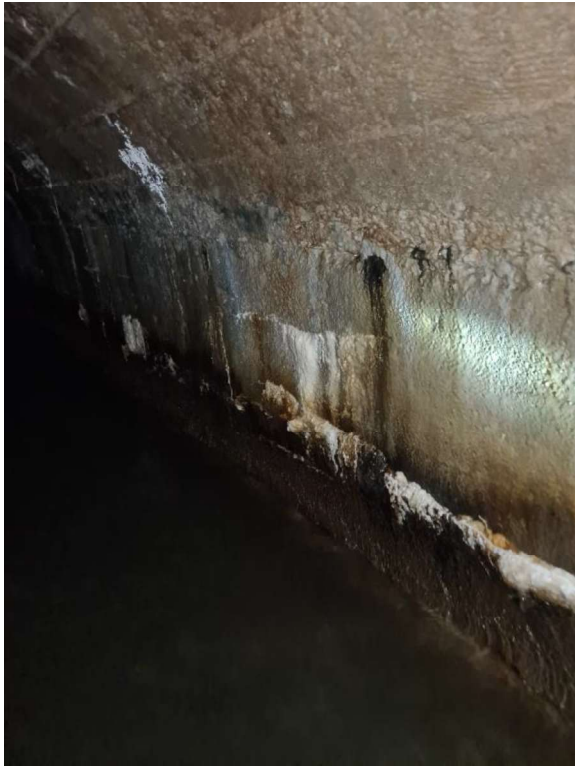
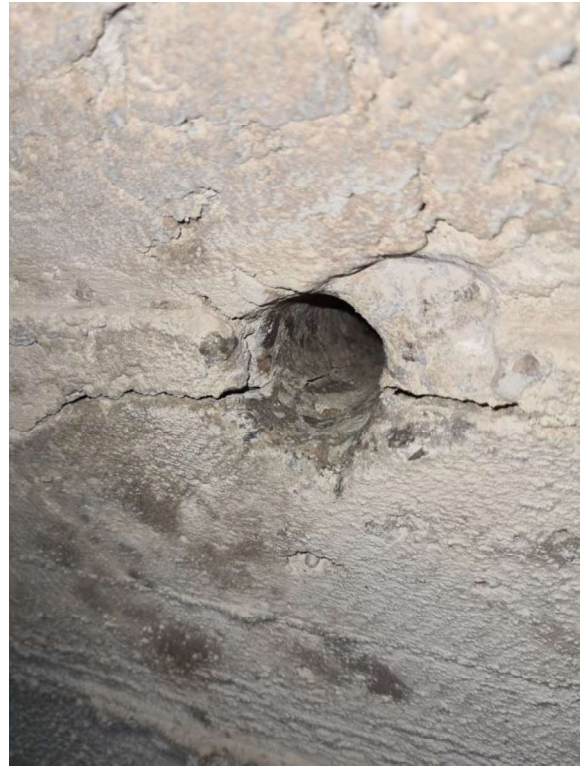
Defects such as eroded concrete and especially cracks at the bend of the tunnel occur almost along the entire length. Most of the damages, as determined by the visual inspection, are superficial, although some cracks are quite open and deep, there are also exposed reinforcements.

Cracks extend along the tunnel as well perpendicular in both directions and their length reaches 30-40 meters. In one of the boreholes made earlier in the construction of the tunnel, the purpose of which is unknown, it is clear that the crack has spread to a considerable depth (see photo below).

Concrete wear cracks and other damage are likely to progress and require timely and appropriate treatment.

Tunneling cracks and erosions - images N11 and N12

Cracks found on the tunnel concrete lining should be treated to prevent their further development and damage to the lining.

Cracks should be treated in the following order:

- cut out in concrete along the cracks no less than 25*25 mm section groove;
- The groove must be cleaned properly, with a water jet or the required gas using
- The cleaned groove should be filled with solution.

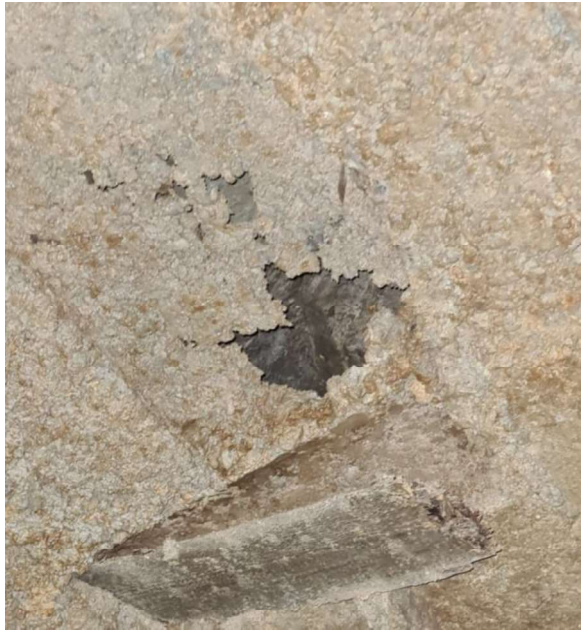
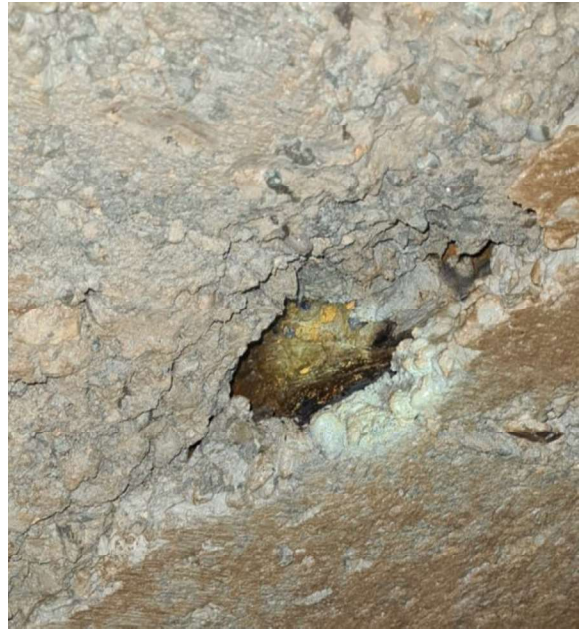
As it was already said, the construction works for the arrangement of the concrete lining of the tunnel are performed in a rather low quality. This opinion is also confirmed by the fact that in some places the insufficient thickness of the screed is clearly visible, because the rock is exposed on the surface of the screed. In some places, mainly in the arch of two contiguous concreting sections, the curve is quite thin, and behind it there are quite large voids. This indicates that backfill cementation was either not performed at all or was performed improperly. At least there is no sign of it.

In addition to visual surveys, small-diameter monitoring holes were drilled along the entire length of the tunnel, with a diameter of 20 meters, with three boreholes at each location: in the arch and on the walls on both sides. With the help of drills, it was possible to determine the actual thickness of the concrete bend and the voids behind the bend.

Insufficient thickness of the tunnel lining and voids - pictures N13 and N14

The voids between the tunnel construction and the surrounding rock should be filled with cementation (filler cementation). Three unit cementing drills should be arranged on each picket - in the arch and in the side walls, at a height of 1.0-1.5 m from the base, with a 6-meter drill (in the middle of the construction seams).

The diameter of the drills should be determined according to the diameter of the tampons to be used. The depth of drilling should be 15 cm added to the thickness of the cutting (variable rate).

Because the purpose of cementing works is only to fill voids, and also, taking into account that the actual condition of the concrete is unknown, the cementing pressure should not exceed 1 bar.

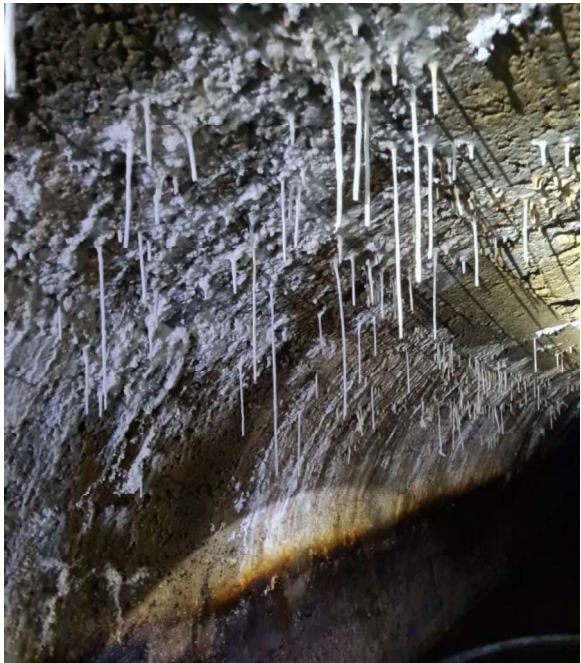
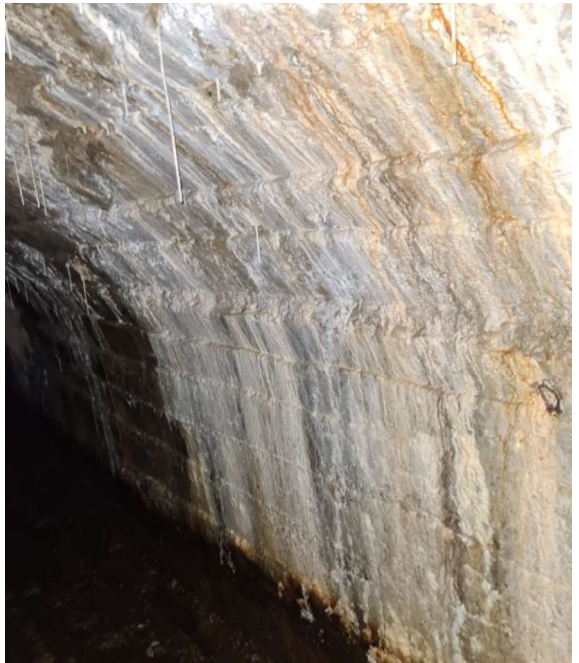
On the arch of some sections of the tunnel, there are significant centers of crystalline discharge, which over time may become the cause of significant damage and even rupture of the tunnel construction. Therefore, the mentioned sections should be given special attention.

Insufficient thickness of the tunnel lining and voids - pictures N15 and N16
