## Tbilisi Mall

### Stage 1, Inspection Report

**Project No.: M8722**

**Document No.: M8722 – RPT 001**

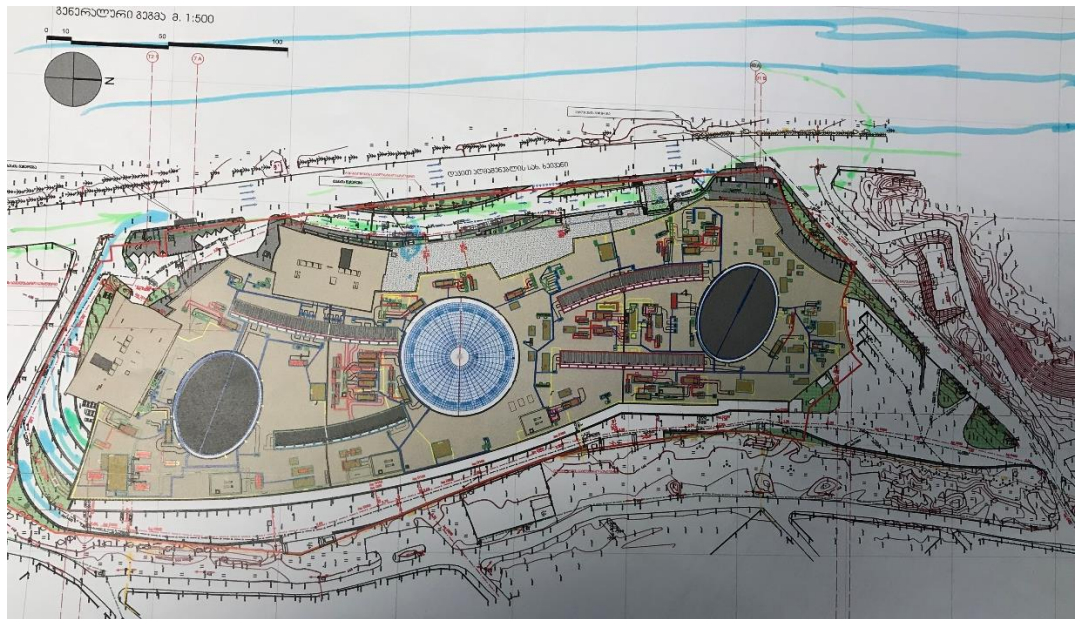
The main entrance is problematic as incoming traffic must cross over the outgoing traffic coming from the basement car park.

Figure 11 - Mall Overview

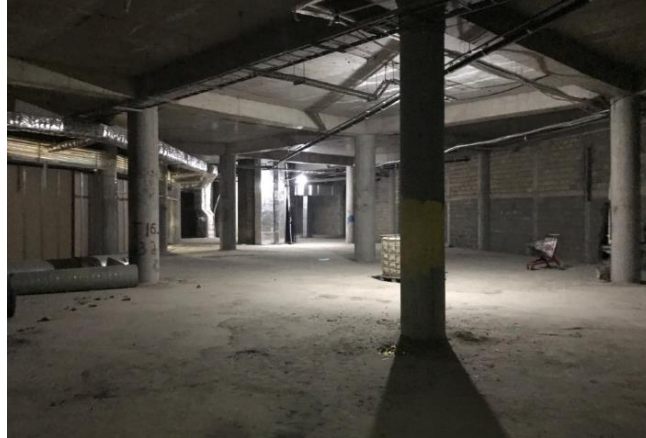
The constructed mall appears to comply with the drawing package. Level 4 of the mall is currently not occupied.

*Figure 12 - Vacant tenancy space on Level 4.*

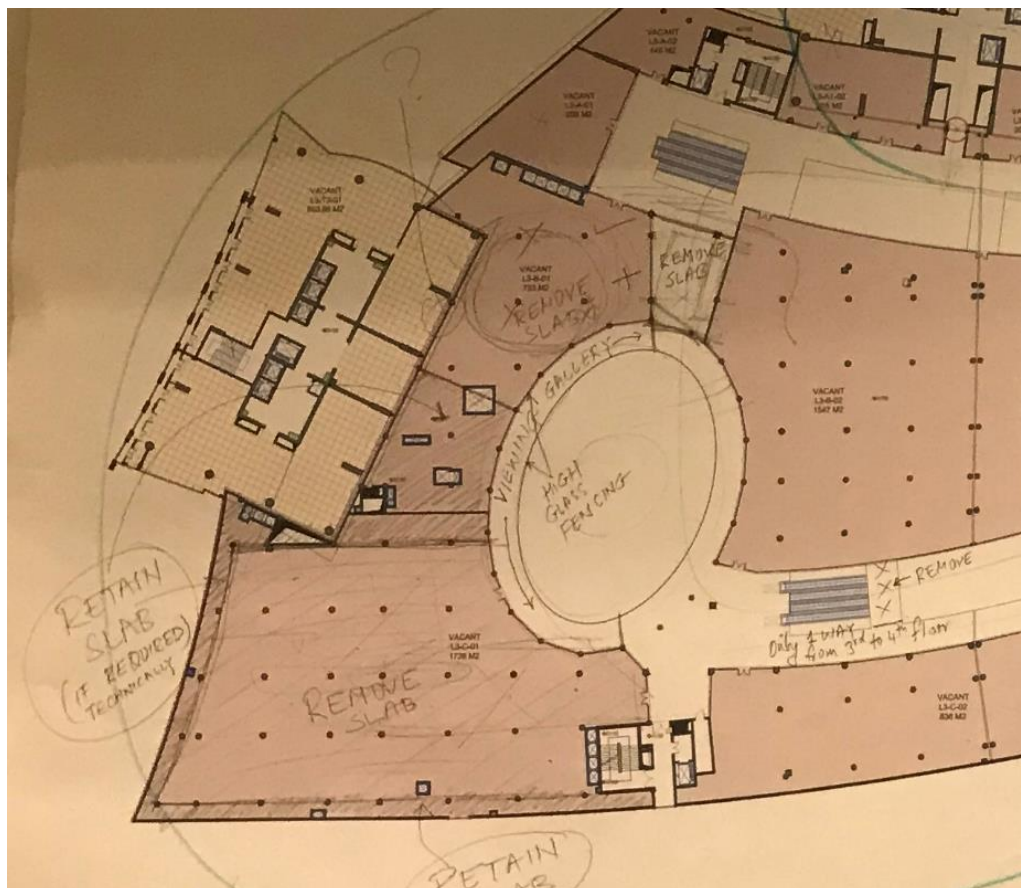
RUD is considering the removal of columns and areas of the slab to accommodate the newly proposed entertainment area on L3/ L4, refer Figure 13 for a sketch of the proposed modifications.

*Figure 13 - Sketches of the Proposed Modifications*

The roof slab directly above this area is highly loaded due to the presence of MEP plant and equipment.
